PATCHBOND

Publishable Synthesis Report

EDA Cat B project : PATCHBOND

Testing of the PATCHBOND demonstrator panel

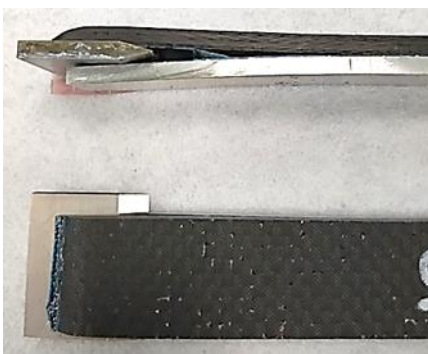
Figure 2 wedge test on composite patch repair of an Aluminium structure

Repair materials and processes were selected from the NH90 repair manual. Some work was performed on composite patch repair of metal structures (see Figure 2).

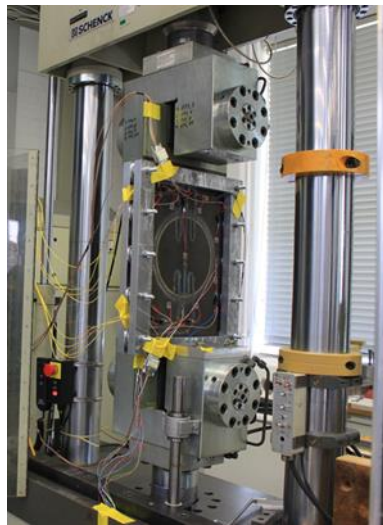
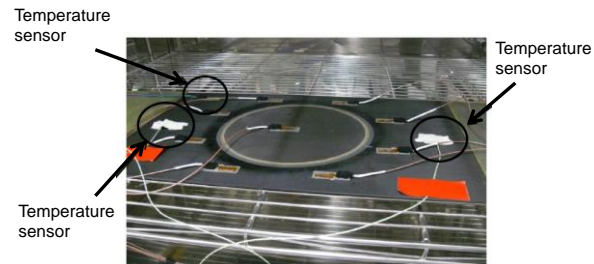
Figure 10 testing of the panel with AU sensors (upper left), detail of the panel (upper right) and location of the impacts (lower)

Part of the work was the investigation of the Acousto Ultrasonic SHM method for composite bonded repair monitoring. Different sensors were tested to investigate their resistance to fatigue loading. Test panels were designed and equipped with AU sensors. The instrumented panels were fatigue loaded and impacts were applied during the test campaign. The ability of the AU system to detect the location and size of the impacts was evaluated including effects of temperature variations and ageing of the sensors.

The system was capable of detecting the impacts (size and location) as indicated in Figure 10. Temperature compensation methods are needed to improve the results.

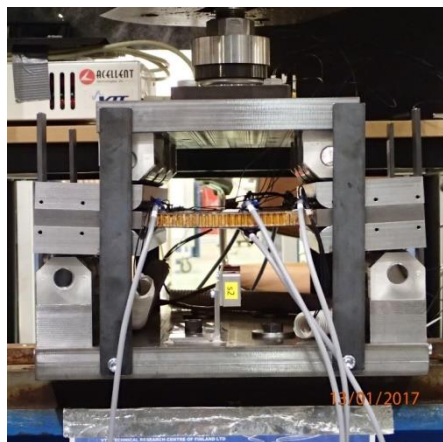
Figure 11 4-point bending test of a sandwich panel with AU sensors

In addition static/dynamic tests were performed for evaluation of the Acousto Ultrasonic (AU) based SHM system concentrating on monitoring damage propagation. Samples were tested in a 4-point bending test fixture (see Figure 11). Due to the brittle nature of the repair a sudden failure occurred during the cyclic loading and controlled damage propagation was not observed.
